TECHNICAL REPORT ARCCB-TR-00008

**EVIDENCE AGAINST HYDROGEN
CRACKING IN GUN BORES: A REPLY**

PAUL J. COTE

MAY 2000

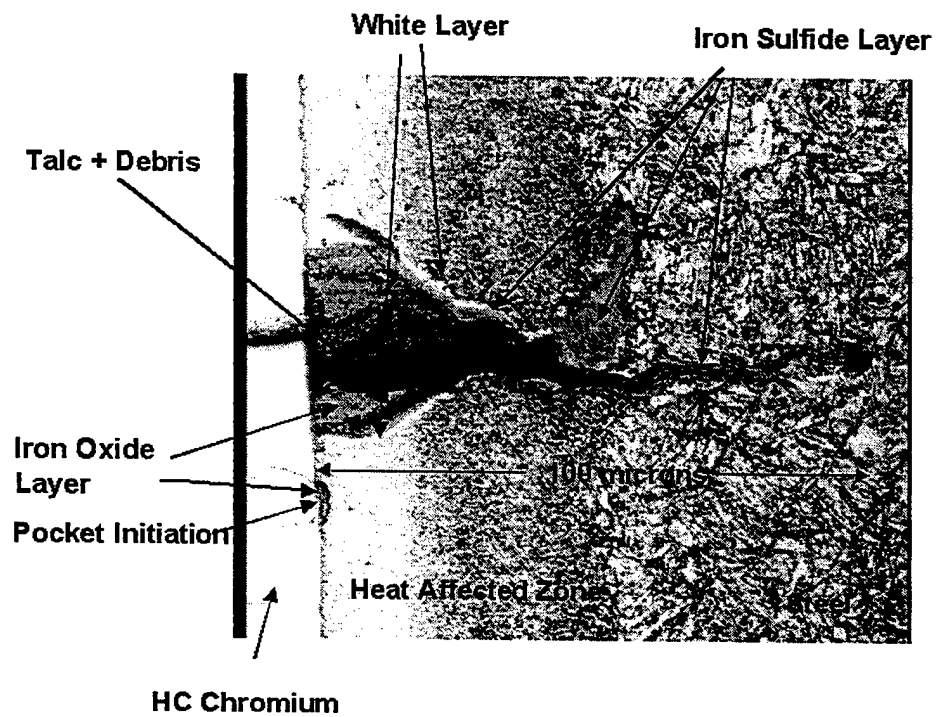
Because of the relatively isotropic nature of the corrosion at the chromium crack tips, and the relatively high volume of steel consumed at that site, it is concluded that fracture in uncorroded steel is not central to damage initiation beneath the chromium. The micrographs in Reference 1 offer straightforward illustrations of the dominant role of chemical attack. Figure 1 is reproduced from that report as an example. The image is from specimen 2, which is a tube that had experienced 220 conventional rounds and 80 experimental high-temperature rounds. The undermining of the chromium coating is clearly shown. Evidence of sulfur, oxygen, and carbon attack (white layer) are all present in this figure. The entire length of the extended erosion pit is coated with a gray layer (iron sulfide).

Finally, the specific issue here is our conclusion (ref 1) that the hydrogen-cracking mechanism proposed by Underwood and Parker (ref 4) is inconsistent with the observed progression of high-temperature corrosion into the steel at the chromium crack tips. Hydrogen cracking is expected to occur at or near room temperature and at atmospheric pressure. Thus, such cracks should be manifested as corrosion-free and debris-free narrow cracks. The proposed hydrogen-cracking mechanism involves interaction of the tensile stress layer (estimated at 500 microns deep), formed on cooling in the heat-affected layer of steel, with the hydrogen supplied by earlier exposure to the high-temperature propellant gas. The distinguishing feature of this proposed mechanism is that the hydrogen cracks ought to be substantially developed (several hundred microns deep) after the first few rounds since the stress layer and the hydrogen are both present after the first few rounds. Such rapid, early fracture is inconsistent with the general observations (ref 1) of relatively slow, gradual progression of corrosion damage into the steel (e.g., Figure 1).

The view (ref 2) that rapid fracture *must* play a role in propagation of damage into the steel is addressed next. It was suggested in Reference 1 that fracture through corroded grain boundaries or through mechanical fatigue and fracture (where there is no corrosion) can also contribute to damage propagation. Hydrogen cracking is considered unlikely, however, for the reasons cited above. It is not clear that fracture into uncorroded steel *must* play a role in the early stages of damage propagation, especially where corrosion rates are high. Consider the results in Figure 1, which has the deep corrosion pits with only 300 total rounds. Assuming the empirically-determined 0.4 micron per round rate of iron sulfide layer formation in propellant environments, and assuming a film rupture process with fresh metal exposure through the sulfide fissures with each firing, one estimates corrosion pit depths of 120 microns. (The estimate is conservative because it ignores the observed diffusion enrichment of the steel by sulfur beneath the scale (~0.3 micron per round)). The estimate is in accordance with the corrosion pit depth of 100 microns in Figure 1, so that rapid fracture of steel is not essential to explain the shape of extended corrosion pits.

Figure 1. Initiation and propagation of high-temperature corrosion into the gun bore surface beneath the chromium coating.

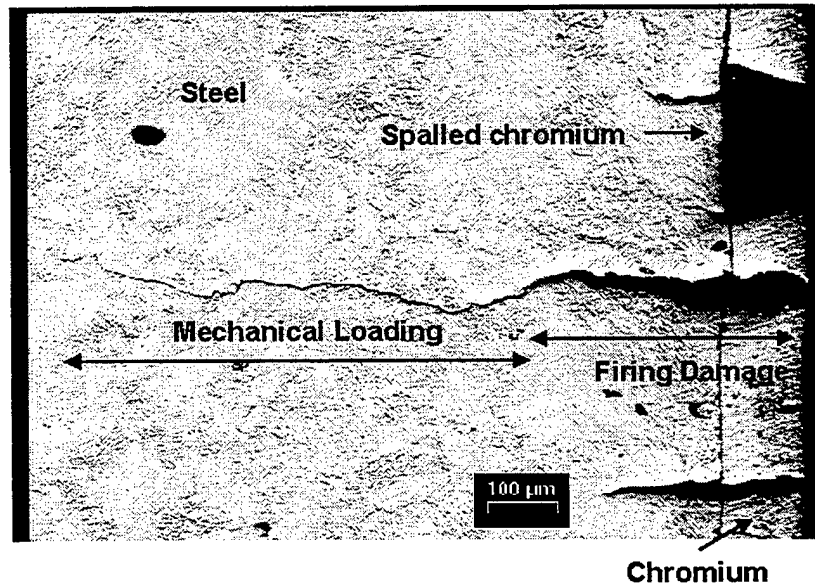
Given the reliance on a meandering crack shape and branching to establish hydrogen cracking, it is useful to examine the shape of fatigue cracks that are produced by pure mechanical loading in a simulated fatigue test using hydraulic pressure. Figure 2 shows results on a 120-mm specimen that had developed significant erosion pits by firing 1246 conventional rounds prior to mechanical testing, where 6593 cycles were applied at 97,600 psi. Hydraulic pressure cycling was applied to develop fatigue cracks for the purpose of establishing safe service lives of eroded tubes. In these specimens, such cracks are easily distinguished from those due to firing because of their narrow widths, long lengths, and absence of corrosion products and firing debris. It can be seen that the fatigue crack grown under purely mechanical cycling has all the features

attributed to classic hydrogen cracks. The longest crack in this specimen was approximately 1-cm in length and exhibits all the features associated with environmental cracking, including branching all the way to the crack tip. This is twenty times deeper than the estimated tensile stress zone (ref 3), so it cannot be attributed to the proposed hydrogen-cracking mechanism. The mean crack growth rate for this mechanically driven crack is over one micron per cycle. Thus, rapid cracking and crack shape are insufficient to establish hydrogen-cracking mechanisms in gun tubes. The usual mechanical fatigue cracks may easily be mistaken for hydrogen cracks with those criteria.

Figure 2 also shows a spalled section of chromium that is typical of what is observed in the survey study (ref 1). In general, the spallation is at or near the chromium/steel interface and as can be seen in this figure, there is no joining of cracks in the steel beneath the chromium.

Figure 2. Portion of the fatigue crack generated by mechanical loading seen to have the same meandering, branching nature usually attributed to classic hydrogen cracking.

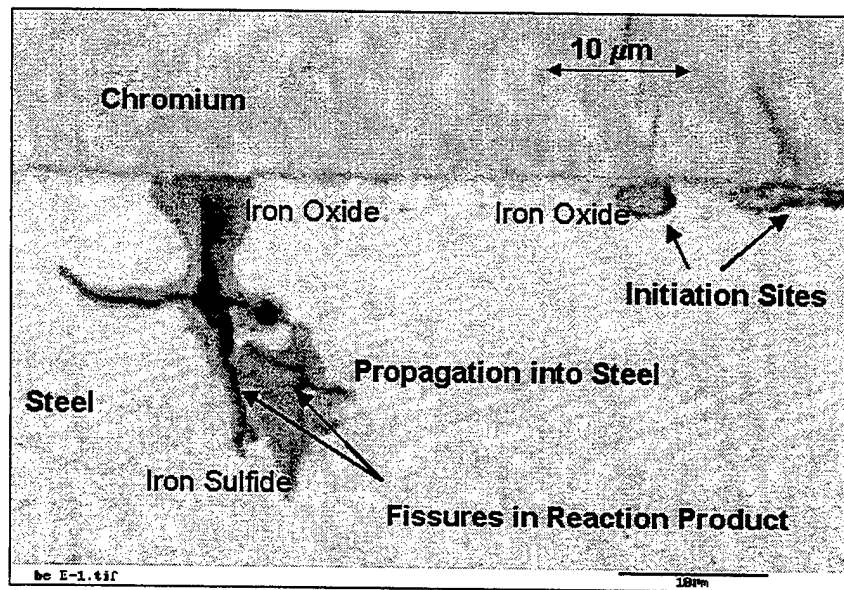
Figure 3 is a scanning electron micrograph (SEM) of typical reaction products that form at the tips of the cracks in the chromium coating for the same specimen as in Figure 1. The fractures in the SEM images are better defined than in optical micrographs. This is the typical result, which provides a straightforward illustration that fracture into uncorroded steel is not observed in early stages of damage. Thus, as illustrated by this figure and by the data in Reference 1, there is no evidence for the predicted incremental hydrogen cracks that are supposed to form at room temperature and pressure (according to the slow mode scenario) after the last round. The only observed fractures are in the form of fissures in the brittle reaction products (sulfides and oxides); these serve to direct the progress of the gas-metal attack into the steel.

Figure 3. SEM illustrating that fracture into uncorroded steel does not occur during initiation of damage beneath the chromium coating.

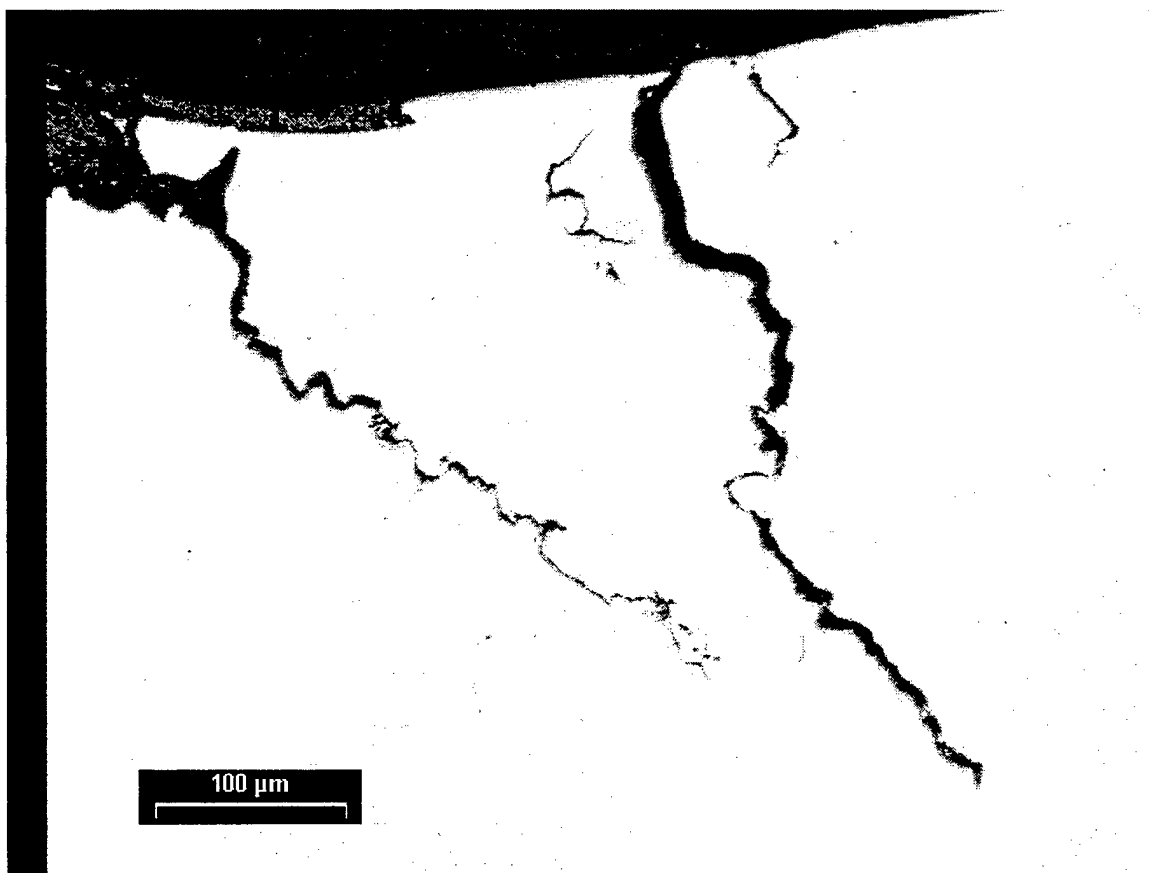
All earlier discussions focused on damage initiation. Figure 4 shows the opposite extreme, that is, several of the deepest fractures in specimen 2. These fractures occurred in a section where the chromium coating and several millimeters of steel had been eroded away. Cracks resembling the one at the left in the figure are used to show that hydrogen cracking may be present since it is assumed (ref 2) that mechanical fatigue alone cannot produce cracks of this length (in 300 rounds). As illustrated in Figure 2, however, this deep, branching, crack pattern is, in fact, consistent with mechanical cracking.

The majority of the deep cracks in this sample resemble the crack at the right in Figure 4 with its blunt crack tip. Crack blunting in deep cracks is probably not due to ductile fracture, since the irregular surface morphologies at the tips do not give the appearance of plastic flow. Regarding the hydrogen cracks that are supposed to form after each firing, one never observes the sharp debris-free hydrogen cracks emanating from any of the numerous blunt cracks in these specimens.

Another notable feature is the general widths of the cracks. Comparison of cracks in Figure 4 with the room-temperature cracks from mechanical loading in Figure 2 show crack widths are, in most cases, roughly a factor of five larger when produced under firing conditions. This suggests a high rate of material removal via gas-metal attack, even for deep cracks in fired tubes. While there are no observable reaction products (gray layers) in the steel at the tips of

these deep cracks, there is evidence of firing debris all along the cracks. For example, energy dispersive x-ray analysis shows aluminum deposited (from the projectiles) and potassium along the full length of even the deepest cracks, indicating exposure to hot gas attack at the crack tips.

Figure 4. Micrograph showing examples of the most severe fractures in specimen 2.
